<b>Date</b>	14 Dec 2015		<b>Release Note #</b>	4500-2077	<b>ECO Ref #</b>	1341
<b>Product</b>	ezfill 4500		<b>Description</b>	Firmware Upgrade		
<b>Revision Change</b>	<b>From</b>	2.01	<b>To</b>	2.02	<b>Created By</b>	J. Yangco

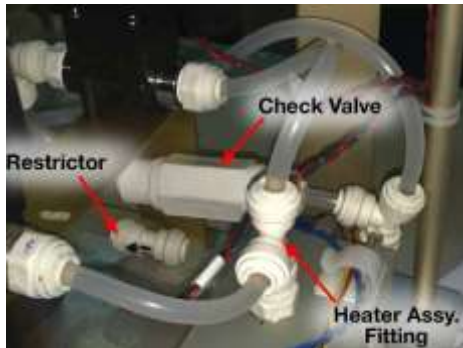
Looking from the inside

<ul style="list-style-type: none"> <li>For 9200-5139 main board ONLY</li> <li>Modify routing of tubing</li> </ul> </div> <hr/> <ol style="list-style-type: none"> <li>Slowed down the cylinder motor speed when instrument starts the dispense cycle in SLS mode. This reduces the pressure and turbulence inside the heater assembly thus minimizing the bubbles from the SLS solution. For this to work consistently, the tubing routing needs to be modified as shown:</li> </ol>

Leave the tubing routing floating and ONLY secure the reservoir line on the valve bracket using a tie wrap.
