Date	28 Sept 2015	Service Note #	TCS-2068	Updated	NA
Product	TCS-0200		Created By	J. Yangco	
Description	Installing the A2D (Analog to Digital) Plug-in Board

Installing the A2D Plug-in Board

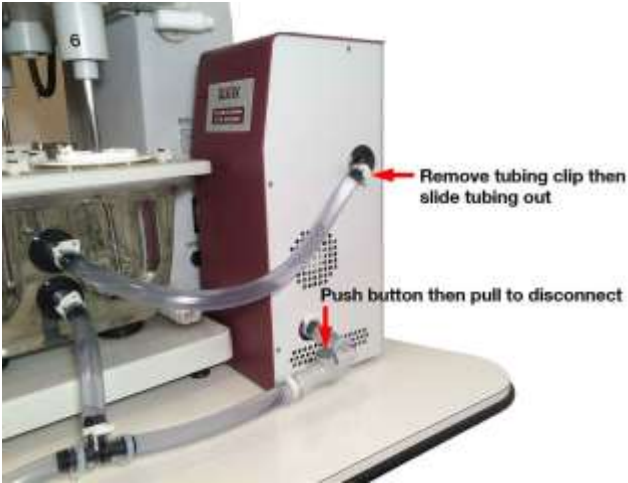
<p>Step 1</p>	<p>Disconnect the TCS tubing starting with the quick disconnect then remove the tubing clip in order to pull the top tubing out as shown. Set the TCS on a clean area to work on.</p>

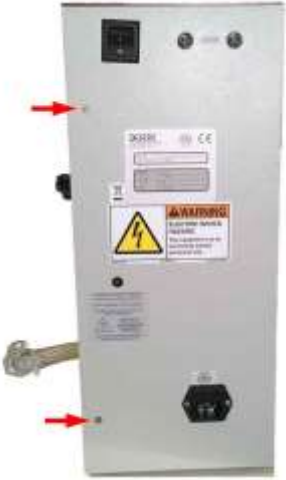
<p>Step 1</p>
<p>Step 2</p>	<p>Open the rear panel by removing the two screws as shown.</p>

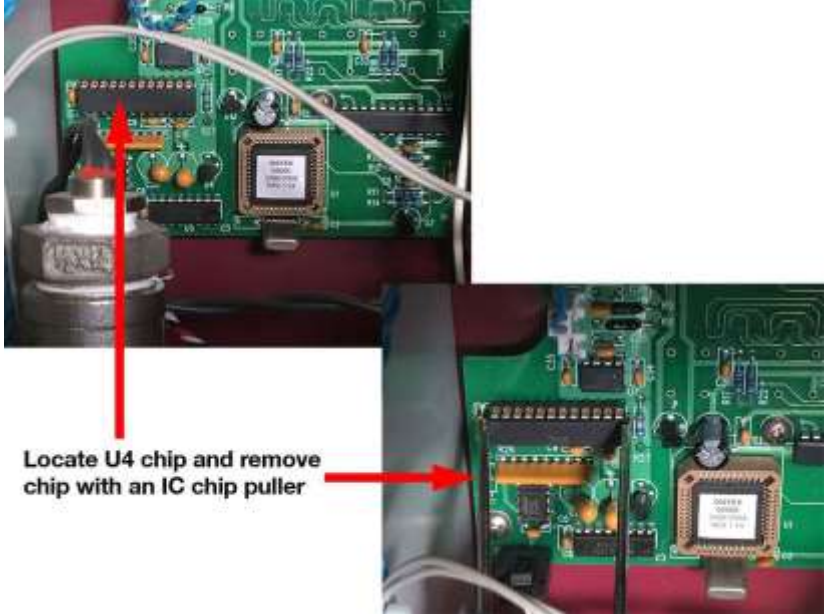
<p>Step 3</p>	<p>With the rear panel open, locate the U4 chip and remove it using a chip puller as shown. Discard the U4 chip.</p>

Reason: Failure trend analysis indicated an intermittent failure resulting in either overheating or the heater not turning on. Upon further investigation and analysis it was determined that overtime, the TCS main board (2400-5123) will malfunction intermittently due to the instability of the oscillator's clock signal to drive the analog to digital chip (U4-ADS1213P).

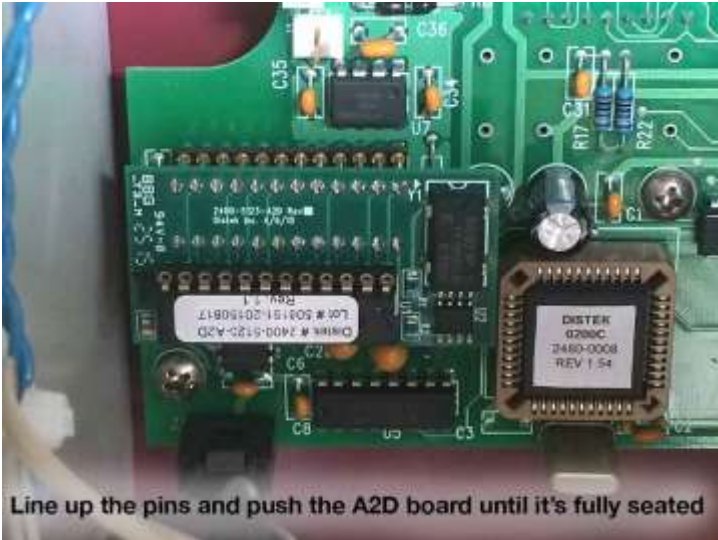
<p>Locate U4 chip and remove chip with an IC chip puller</p> <p>Step 3</p>
<p>Step 4</p>	<p>Prepare the A2D Board. Line up the two rows of pins with the U4 socket and push the A2D board until all pins are fully seated as shown.</p>

<p>Line up the pins and push the A2D board until it's fully seated</p> <p>Step 4</p>

In order to address this issue a design change in the circuitry via a plug-in board was implemented. This enhancement will improve the stability of the oscillator's clock signal performance used for the analog to digital chip.
